UBC/Pacific Spirit Park Cliff Erosion Management Planning

Consultation Discussion Document

July 31, 2000

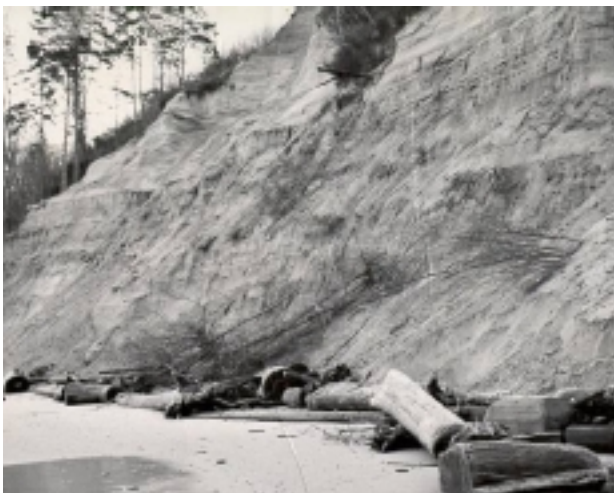
1968 – Low tide showing logs which hit the cliff 4 feet higher at high tide

1968 – Trees and roots on beach as a result of toe erosion

⇒ The berm and drift sill protection works erected in 1981 were evaluated in 1992 for effectiveness. The consultant's review indicated that most of the work had held up well and had been effective in reducing or eliminating shoreline erosion. Some maintenance work was required, particularly at the northern end. Presently, the berm is almost gone in areas of Tower Beach. Much of the cliff base remains exposed to this day and it was also noted that the areas left unprotected had suffered continual damaging erosion. Much of this erosion is due to littoral drift (wave scour aided by logs pounding the cliff toe) at high tide and during storms.

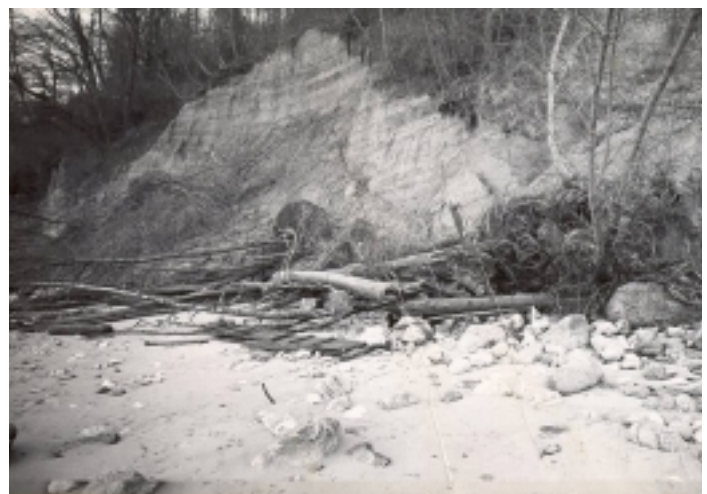
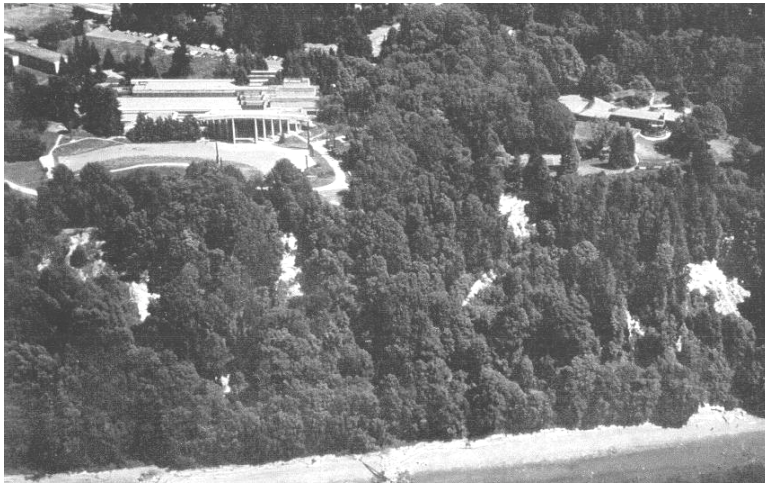
*1998 – Cliffs below
Museum and
Mackenzie House*

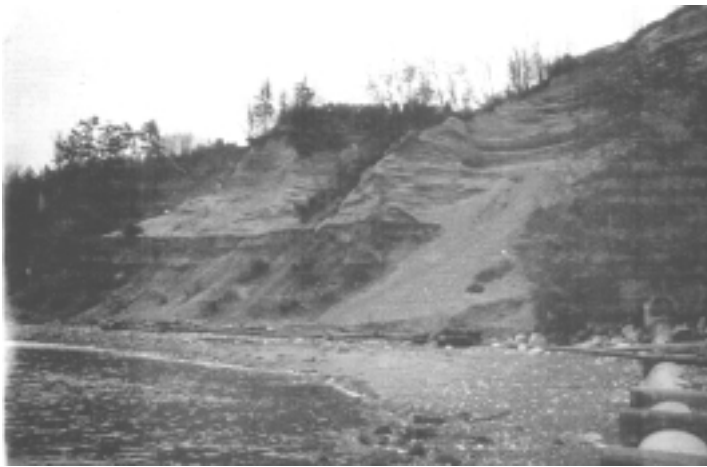
1976

Cliffs below Cecil Green Drive and Museum grounds before and after re-vegetation

1992

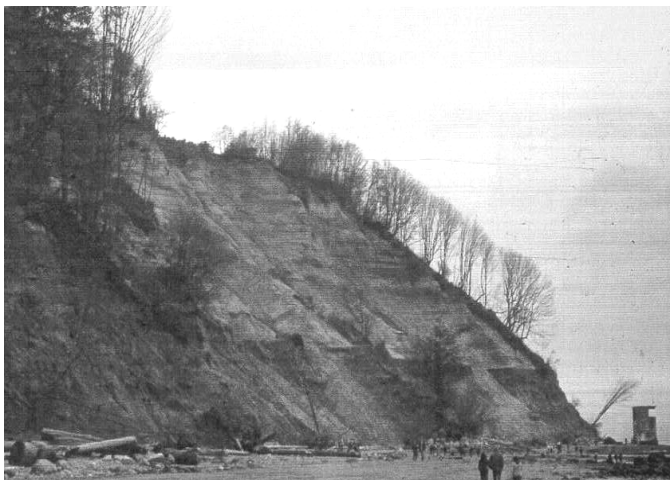
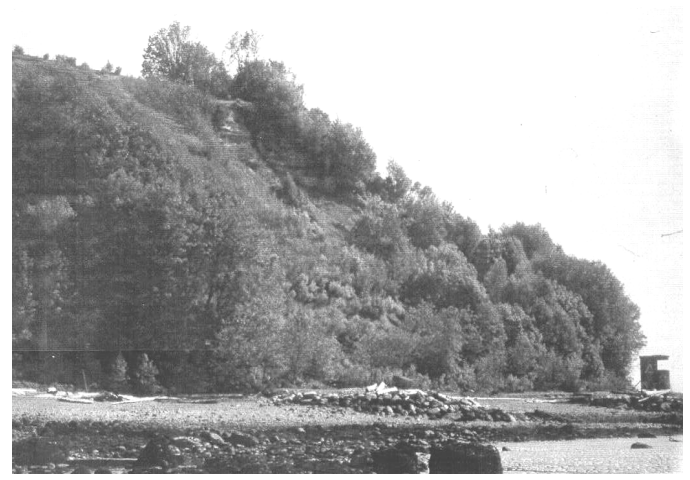
1974

Cliffs below Museum before and after re-vegetation

1992

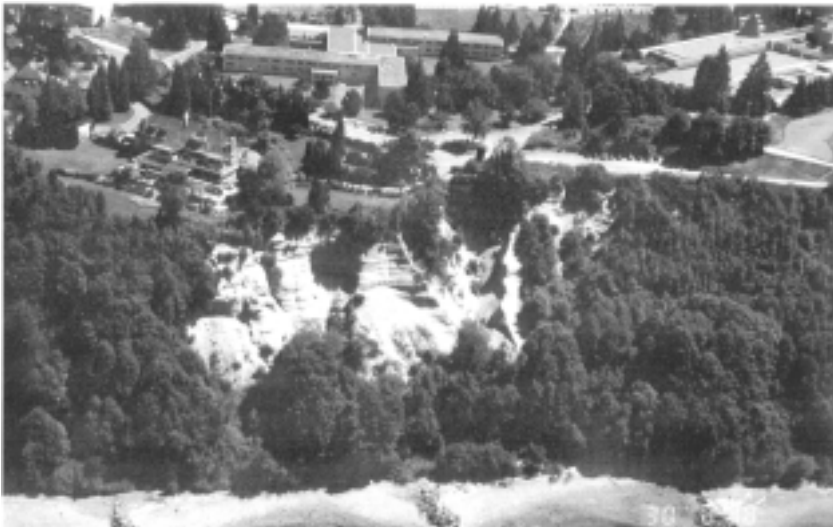
*1998 – View of
cliffs at Cecil
Green House –
note deep gully at
right*

- ⇒ Cecil Green House and Coach House are both effected by erosion. A storm in 1994 caused significant erosion directly adjacent to the Coach House and another storm in 1997 furthered the erosion. These buildings have considerable historical value and their location above the cliffs is a cause for concern.
